# OCEAN MARINE SURVEYS

### PRE-PURCHASE SURVEY OF:

**Type**            Power  
**Name**            [REDACTED]  
**Class**            Princess 45 - Flybridge

[REDACTED] 2013

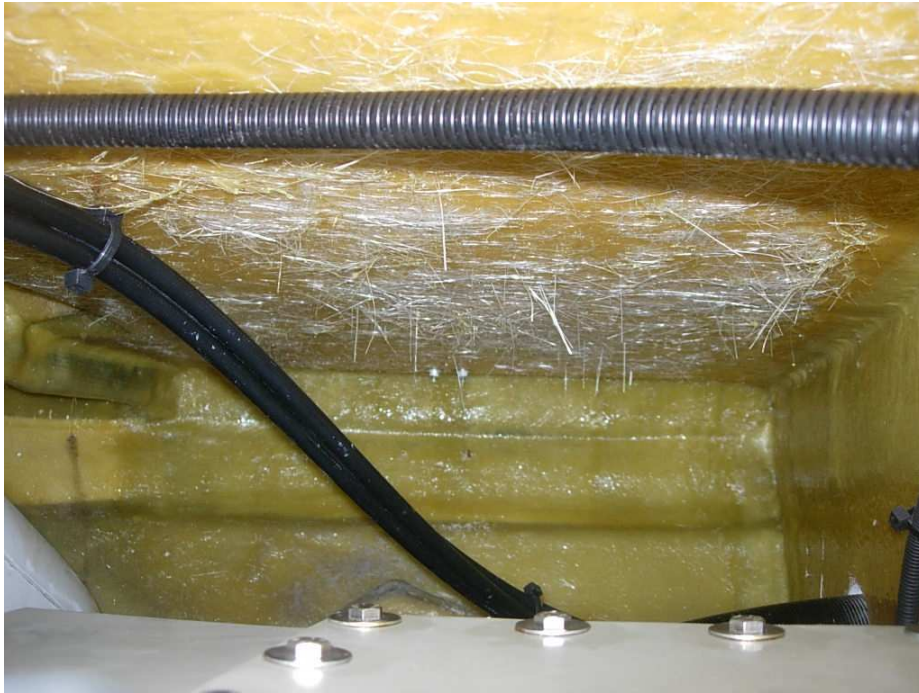
**Figure 1**

Internally, below the swim platform to starboard there is an area approximately 40cm<sup>2</sup> where the laminate has failed to become fully saturated during construction and remains un-consolidated. Access to this area was limited so I wasn't able to easily determine how deep this dry area extended but from my visual examination and further examination of photographs, I don't believe it extends much deeper than the last layer of glass fibre chopped strand mat. (See figure 1).

*Area of dry laminate below the swim platform to starboard.*

I didn't see any further examples of this resin starvation during my examination so it's possible this defect is isolated, however it should be noted that linings etc. cover most of the laminate of the deck moulding and as such could not be examined.

Currently the vessel has been in service 8 years and as yet there is no evidence of cracking, sagging or other related deterioration of this area. However, this area is more venerable to moisture ingress than the rest of the laminate and over time some deterioration is inevitable.

To address this issue the dry laminate needs to be ground back to solid material and 2-3 layers of woven cloth (as necessary) laminated back in its place to restore structural strength and to "seal" the laminate structure from future moisture ingress. This will be a difficult area to work due to the limited access; better access would be gained if the starboard water tank were removed although this will add significantly to the cost of the repair.

***(S) A localised repair should be undertaken to remove the dry laminate in way of the swim platform (internally) to starboard and to reinforce and seal the laminate from potential moisture ingress.***
