OCEAN MARINE SURVEYS

PRE-PURCHASE SURVEY OF:

Type Power
Name [REDACTED]
Class Fairline Targa

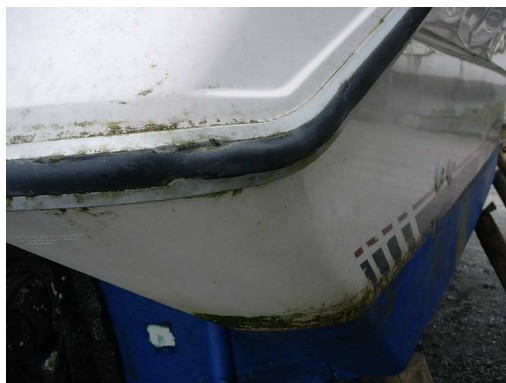
Figure 1

The rubbing strake is an aluminium extrusion with a rubber insert. There are a number of areas where this rubber insert has become damaged from abrasion. These areas of damage are most significant as follows:

- Both aft quarters of the swim platform. (See figure 1)
- An area to starboard, outboard of the aft end of the cockpit where a 4 - 6 inch section of the rubber is missing. (See figure 2)
- Starboard side above the letter P of the vessel's name.
- Immediately forward of the forward most window in the deck moulding to port.

Damage to rubbing strake on the stern quarter to starboard

(C) Give some consideration to suitable repairs to the areas of damage associated with the rubbing strake outlined above.

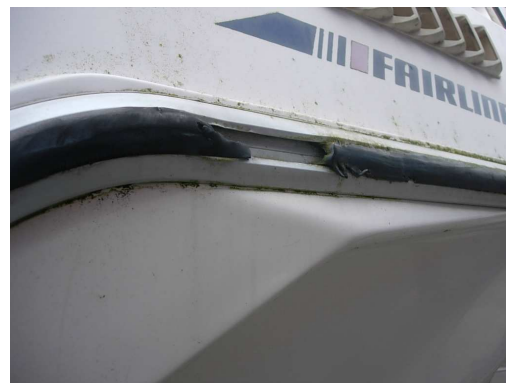
Figure 2

Damage to the rubbing strake outboard of the aft end of the cockpit to starboard.

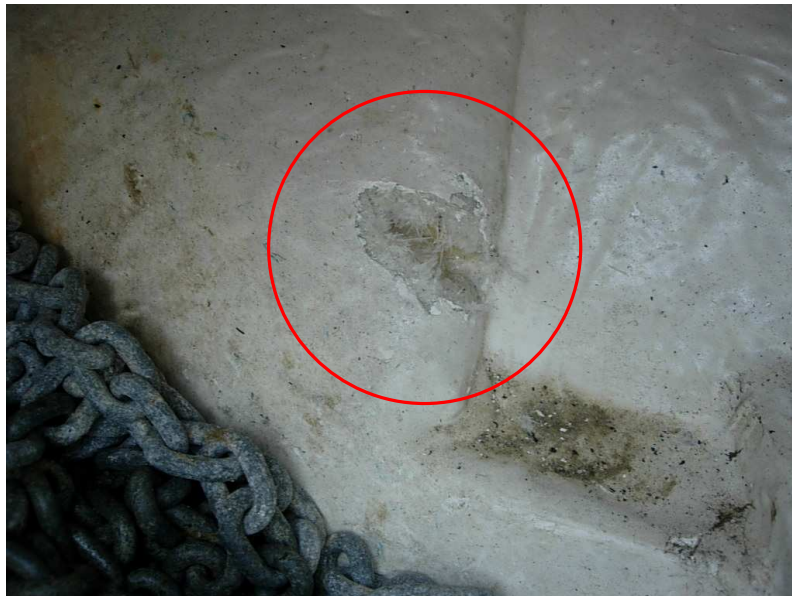
Figure 3

- Small area of impact damage in the way of a structural reinforcement in the anchor locker. (See figure 3).

Small area of impact damage to a structural reinforcement inside the anchor locker on the starboard side forward.

Hammer sounding around this area of damage did not reveal any areas of delamination extending further than the visible area of damage and moisture readings were not found raised. I do not consider this damage to be of structural significance at this stage but it is now necessary to seal this area of damage to prevent moisture ingress in the future. Consideration should also be given to a suitable method of securing the anchor whilst under way which is the most likely culprit as to the cause of this damage.

(R) Repair the area of damage to the structural member in the anchor locker to prevent moisture ingress to the laminate and deterioration of this structural element (See figure 3). This work should be undertaken prior to continued use of the vessel.

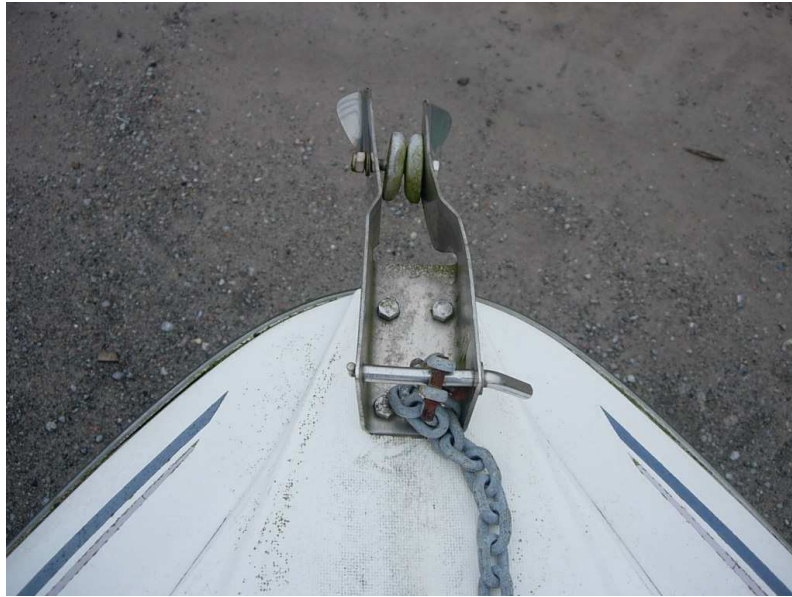
Figure 4
Anchor roller.

The anchor roller is a stainless steel fabrication with a nylon (or similar) roller unit and a pin to prevent the anchor from jumping off the roller whilst underway. The nylon roller has worn to the extent that it is now broken into 2 parts and is of little further use. Further to this the stainless steel cheeks have been bent out of shape. This unit represents an important safety feature on any vessel and as such requires straightening and replacement of the roller such that it may be used efficiently in the event of an emergency. (See figure 4 on next page).

(R) This stainless steel anchor roller fabrication requires straightening and replacement of the nylon (or similar) roller unit. This work should be undertaken prior to continued use of the vessel.

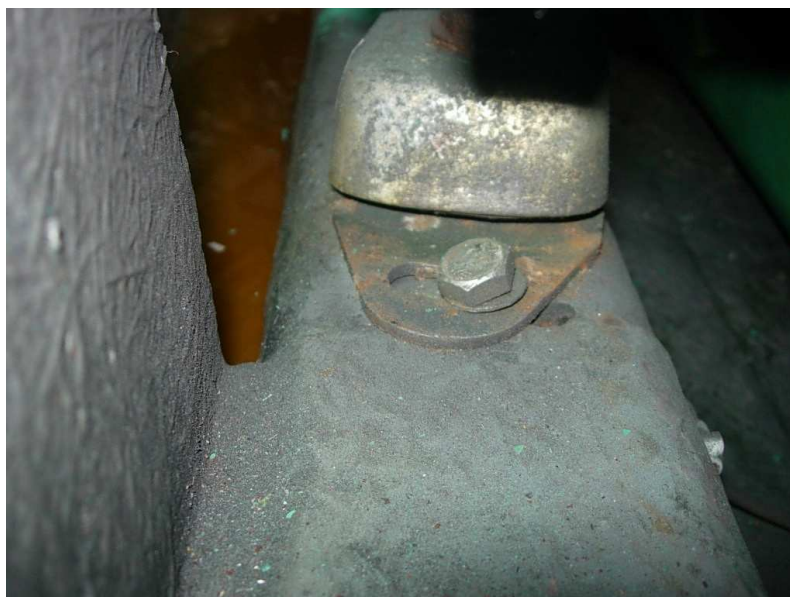
Figure 5

Examination of the engine mounts revealed the starboard mount of the starboard engine and the port mount of the port engine to be misaligned. This misalignment is most significant on the starboard engine. (See figure 5).

Starboard engine starboard side mount misaligned with fixing bolt leaning over to one side.
