OCEAN MARINE SURVEYS

PRE-PURCHASE SURVEY OF:

Type Sailing sloop

Class Twister 28

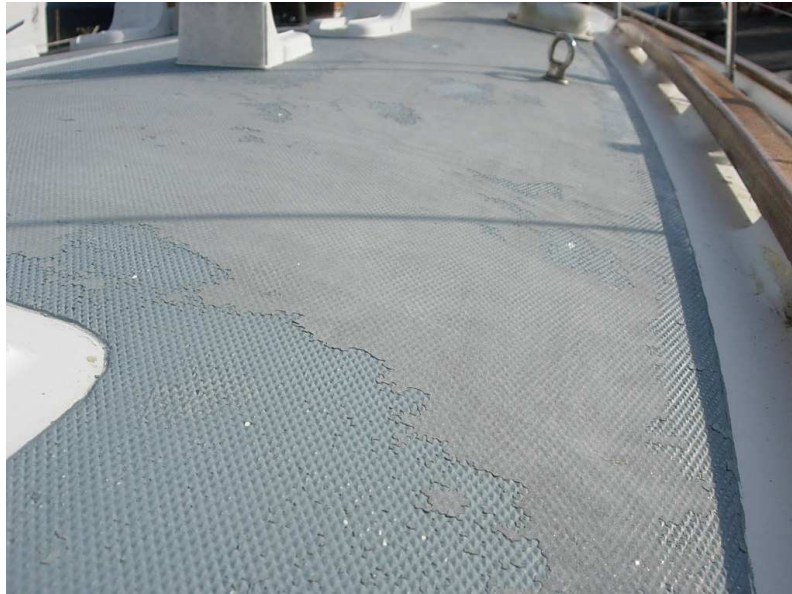
Figure 1

The non-slip surface is achieved via a diamond print moulded into the original gelcoat finish although this has now been refinished with non-slip paint. This paint is flaking off in a number of areas and now detracts from the overall aesthetics to some degree. Cleaning up and re-finishing the non-slip areas would certainly enhance the vessel's overall appearance. (See figure 1).

Non-slip is paint flaking in areas over the deck and coachroof.

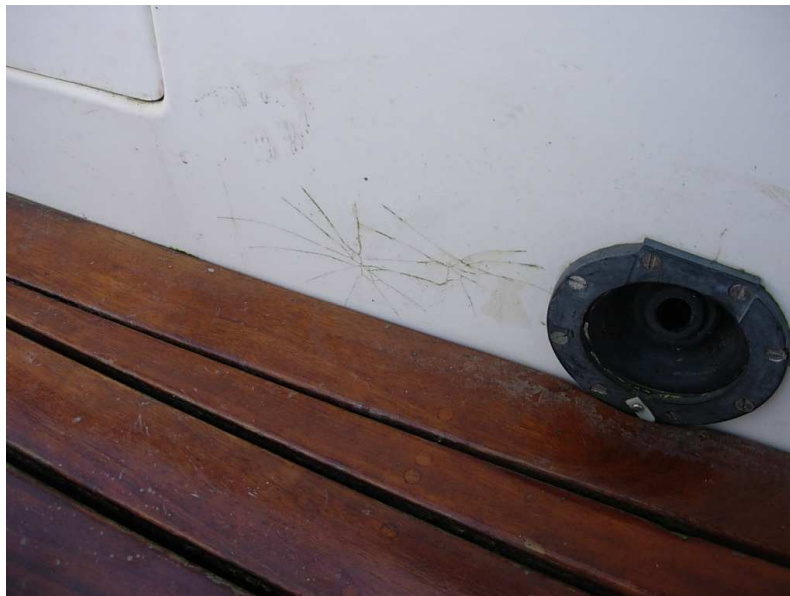
There were 2 areas of stress crazing noted on the port side of the cockpit well and a further area of crazing at the aft end of the cockpit to starboard. Moisture readings taken over the areas of this crazing were not raised and hammer sounding did not reveal any delamination as such I do not consider these to be of any structural significance. (See figure 2).

Figure 2
Areas of crazing in cockpit well to port.

The appearance of this crazing will be greatly reduced if it is cleaned or polished and a heavy coat of wax applied annually will help prevent any moisture ingress to the laminate in the future.

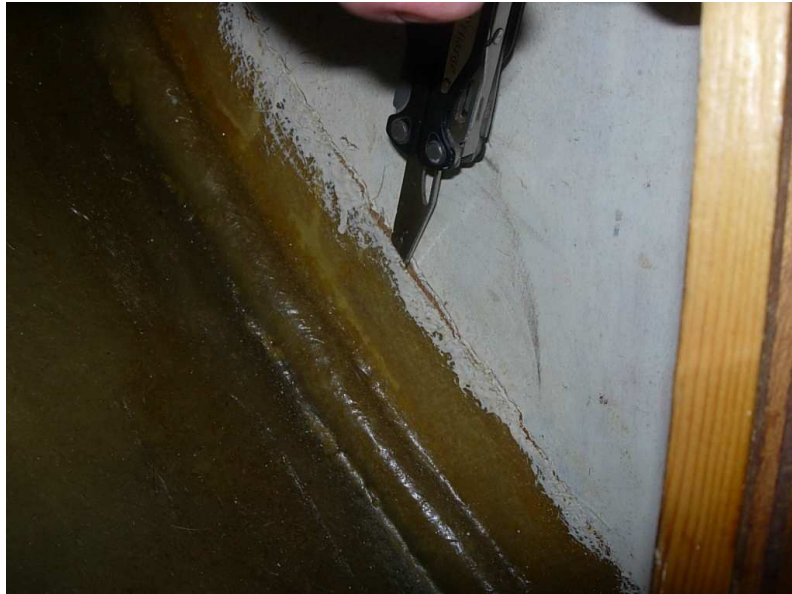
Figure 3

1. Intermediate bulkhead immediately forward of the forward most main bulkhead. The tabbing associated with this intermediate bulkhead has failed on the aft side of the bulkhead to port. Access to this area of tabbing can be gained under the berth to port. (See figure 3).
2. Intermediate bulkhead immediately forward of the galley to starboard. The tabbing associated with this intermediate bulkhead has failed on the aft side of the bulkhead. Access to this area of tabbing can be gained through the small cabinet door below the stove.

Tabbing detached from intermediate bulkhead in forepeak.

I do not consider this defect to be of structural significance at this stage. However it is prudent to address these minor defects early before they develop into more significant structural problems. An easy repair can be carried out to the areas outlined above by prising the tabbing away from the bulkhead and injecting thickened epoxy. Additional reinforcement can then be added by through bolting the tabbing onto the bulkhead using 5mm pan head bolts with penny washers on each side.

(S) Give some consideration to a suitable method of repair with regards to the detached tabbing in the 2 areas outlined above. Failure to address this currently minor defect in a timely manner could lead to a more significant and costly repair in the future.

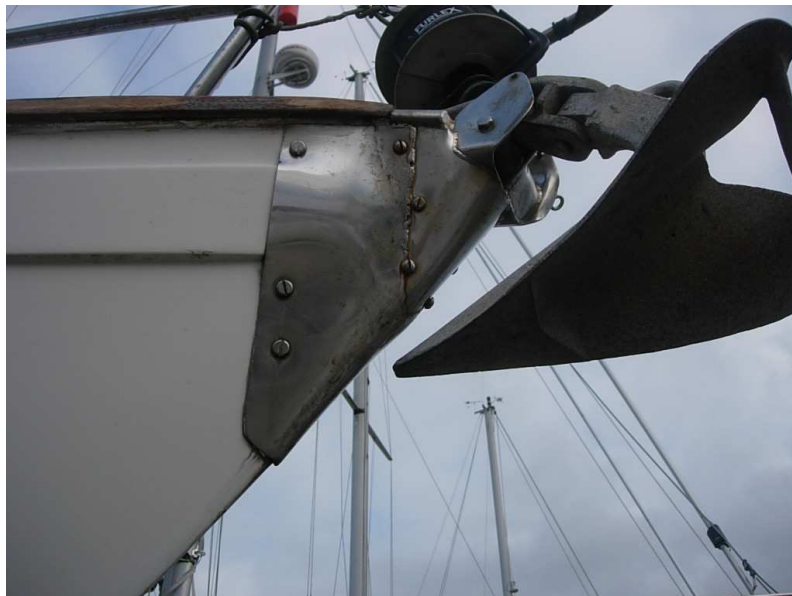
The forestay attaches to the stem head fitting which is integral with the anchor roller. This unit is of stainless steel and found securely through bolted into the hull and foredeck. As far as can be ascertained the stem head fitting has been modified at some point to extend the flanges that lie on the port and starboard side of the hull and around the stem. Although this modification looks somewhat home made it was found secure and will benefit the overall strength of this fitting. (See figure 4).

Figure 4
Modification to stem head fitting.

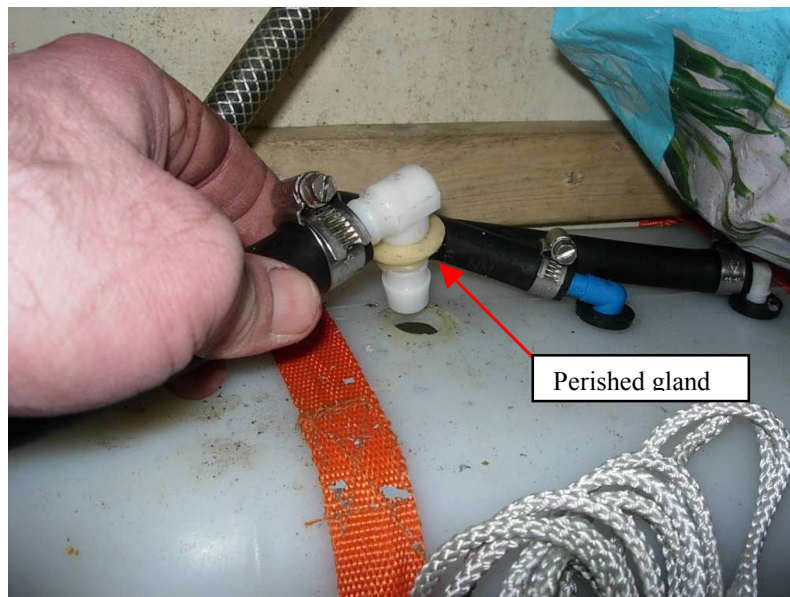
Figure 5

The single plastic fuel tank is located at the forward end of the cockpit locker to starboard, capacity undetermined. The tank was seen secure and where visible all associated hoses were secure with the exception of the breather pipe. This pipe relies on a rubber gland to seal and hold the pipe barb into the tank. This gland has perished and the associated breather pipe has come loose leaving an open hole in the top of the tank. (See figure 5).

The inner section of this gland has perished such that the fuel breather hose is no longer secure to the tank.
